# Home Report

# Single Survey

| Property address | 3 St. Blanes Road<br>Heathhall<br>Dumfries<br>DG1 3RH |
| Date of inspection | 14/09/2026 |

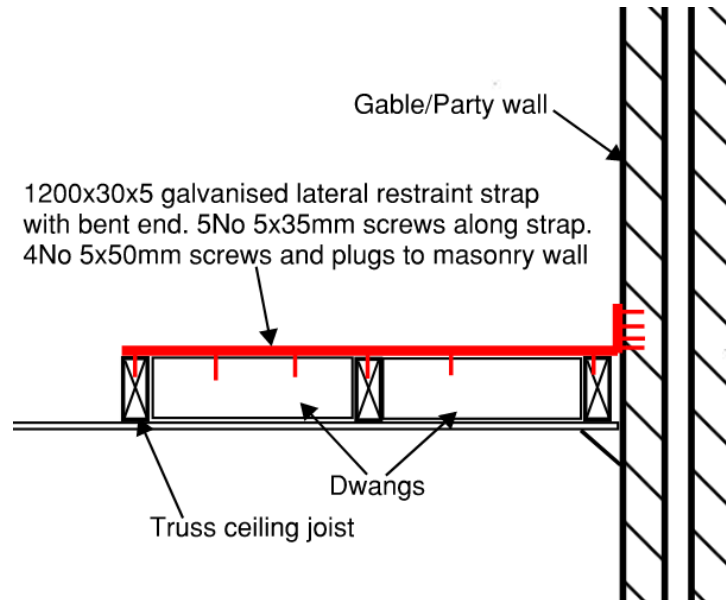
Lateral restraint strap detail for ceiling joists. Also apply to rafters (strap to underside of rafters)

- Replace sealant within formed movement joints below bedroom windows to infill the joint fully. Sealant should be capable of a minimum of 50% elongation and compression.
- The rear bedroom window requires replacement render to the right-hand side jamb (as viewed).
- Replace cracked plaster finish above and below the windows where they occur. Install over an expanded metal lath to improve the lifespan of the repair. Extend lath 500mm to either side of the crack.
- Provide lateral restraint ties between roof truss ceiling joists and party wall, and between truss ceiling joists and gable wall. Install at 1200mm horizontal centres. Use 1200x30x5mm galvanised mild steel straps with bent ends. Install over full depth dwangs between ceiling joists. Fix to masonry with minimum 4No 5x50mm screws and plastic plugs. Fix along dwangs with minimum 5No 5x35mm screws, evenly spaced along straps.

- A restraint of the masonry spandrel panels to the roof truss rafters is also not apparent. While no current defects are directly related to this, it would better ensure the robustness and longevity of the house to install the same lateral restraint straps between the masonry walls and roof truss rafters. Install straps over dwangs as per a ceiling level with straps and fixings to the same specification.
