Home Report

Scottish Single Survey

Property address	4 St. Marys Church Academy Road Moffat DG10 9HP
-------------------------	--

Prepared by	Shepherd Chartered Surveyors
--------------------	------------------------------

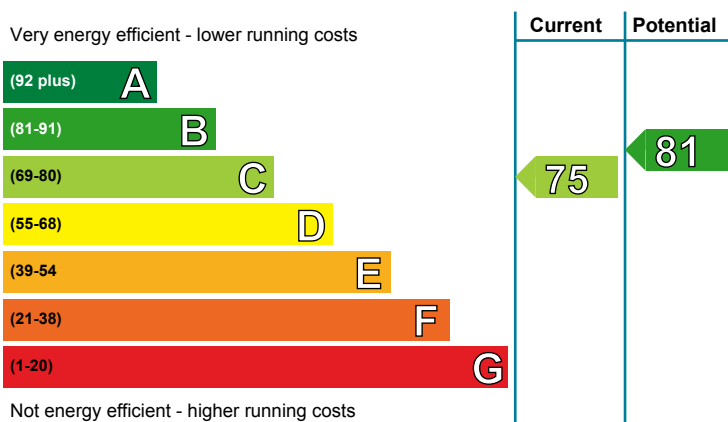
Energy Efficiency Rating

This graph shows the current efficiency of your home, taking into account both energy efficiency and fuel costs. The higher this rating, the lower your fuel bills are likely to be.

Your current rating is **band C (75)**. The average rating for EPCs in Scotland is **band D (61)**.

The potential rating shows the effect of undertaking all of the improvement measures listed within your recommendations report.
