# YOUR ONESURVEY HOME REPORT

North Corner  
Carsethorn, Dumfries  
DG2 8DS

# SINGLE SURVEY

A report on the condition of the property, with categories  
being rated from 1 to 3.

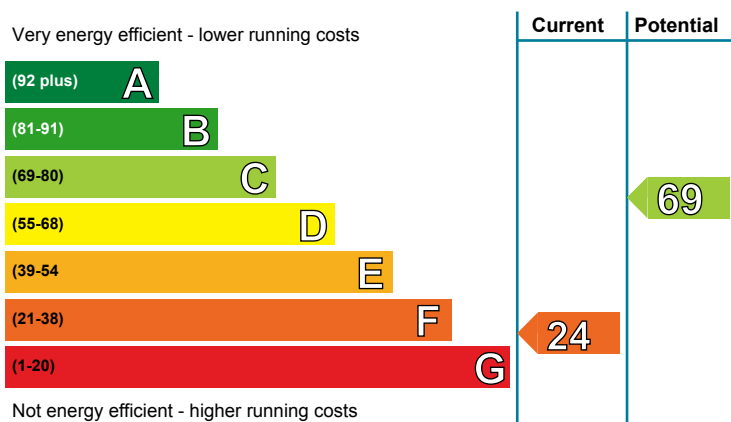
## Energy Efficiency Rating

This graph shows the current efficiency of your home, taking into account both energy efficiency and fuel costs. The higher this rating, the lower your fuel bills are likely to be.

Your current rating is **band F (24)**. The average rating for EPCs in Scotland is **band D (61)**.

The potential rating shows the effect of undertaking all of the improvement measures listed within your recommendations report.

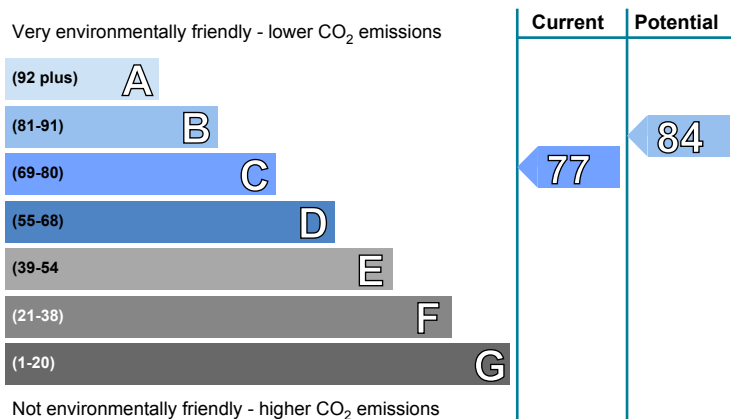
## Environmental Impact (CO<sub>2</sub>) Rating

This graph shows the effect of your home on the environment in terms of carbon dioxide (CO<sub>2</sub>) emissions. The higher the rating, the less impact it has on the environment.
