# Home Report

# Scottish Single Survey

| <b>Property address</b> | 69 Lochside Road<br>Dumfries<br>DG2 0DZ |
| <b>Prepared by</b> | Shepherd Chartered Surveyors |

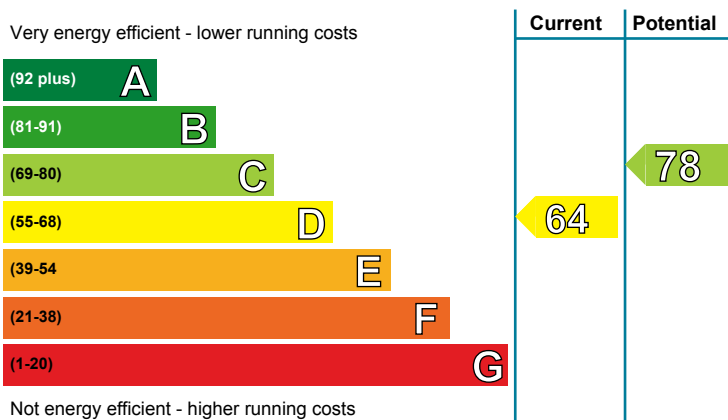
## Energy Efficiency Rating

This graph shows the current efficiency of your home, taking into account both energy efficiency and fuel costs. The higher this rating, the lower your fuel bills are likely to be.

Your current rating is **band D (64)**. The average rating for EPCs in Scotland is **band D (61)**.

The potential rating shows the effect of undertaking all of the improvement measures listed within your recommendations report.
