# Home Report

# Single Survey

<b>Property address</b>	7 Palmerston Drive Dumfries DG2 9DP
-------------------------	---

<b>Prepared by</b>	Shepherd Chartered Surveyors
--------------------	------------------------------

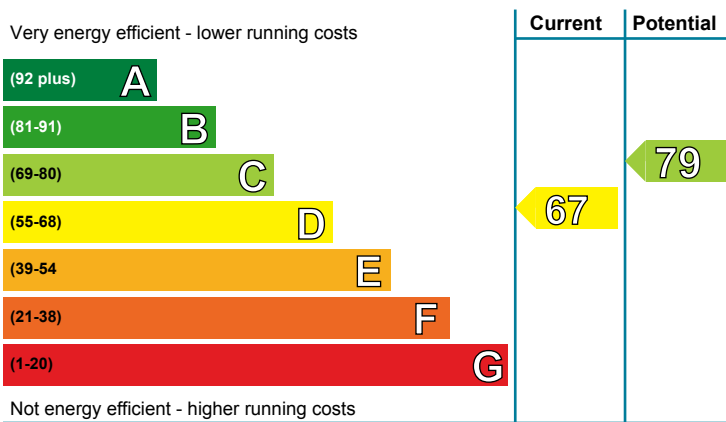
## Energy Efficiency Rating

This graph shows the current efficiency of your home, taking into account both energy efficiency and fuel costs. The higher this rating, the lower your fuel bills are likely to be.

Your current rating is **band D (67)**. The average rating for EPCs in Scotland is **band D (61)**.

The potential rating shows the effect of undertaking all of the improvement measures listed within your recommendations report.

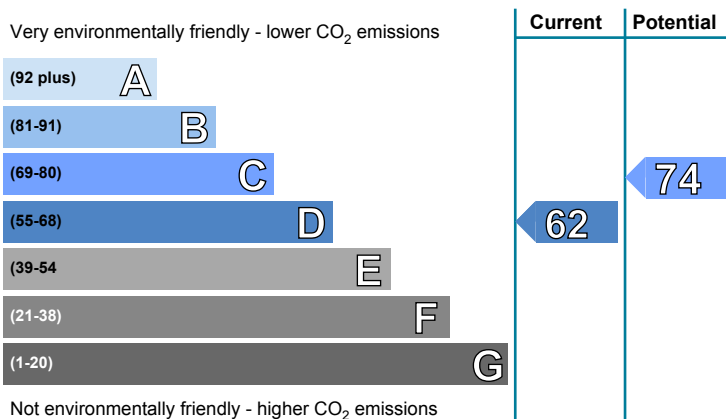
## Environmental Impact (CO<sub>2</sub>) Rating

This graph shows the effect of your home on the environment in terms of carbon dioxide (CO<sub>2</sub>) emissions. The higher the rating, the less impact it has on the environment.
