YOUR ONESURVEY  
**HOME REPORT**

11 Welldale Park  
Dumfries  
DG2 7RA

# SINGLE SURVEY

A report on the condition of the property, with categories being rated from 1 to 3.

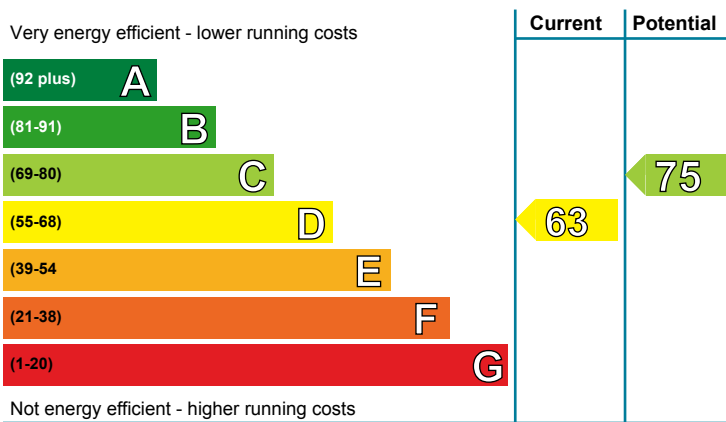
## Energy Efficiency Rating

This graph shows the current efficiency of your home, taking into account both energy efficiency and fuel costs. The higher this rating, the lower your fuel bills are likely to be.

Your current rating is **band D (63)**. The average rating for EPCs in Scotland is **band D (61)**.

The potential rating shows the effect of undertaking all of the improvement measures listed within your recommendations report.

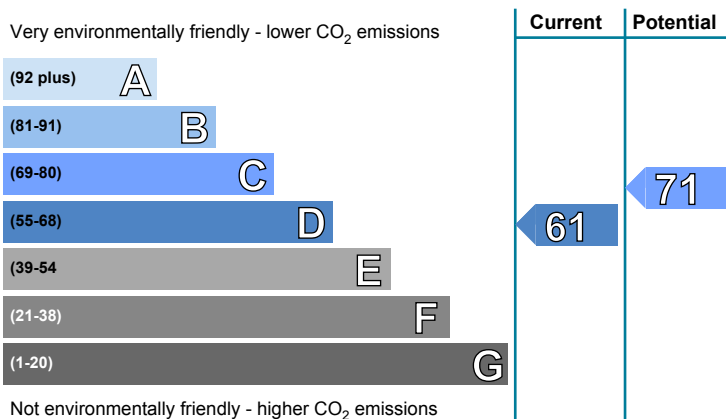
## Environmental Impact (CO<sub>2</sub>) Rating

This graph shows the effect of your home on the environment in terms of carbon dioxide (CO<sub>2</sub>) emissions. The higher the rating, the less impact it has on the environment.
