# Home Report

# Scottish Single Survey

survey report on:

| Property address | Hamilton House<br>Throughgate<br>Dunscore<br>Dumfries<br>DG2 0UG |

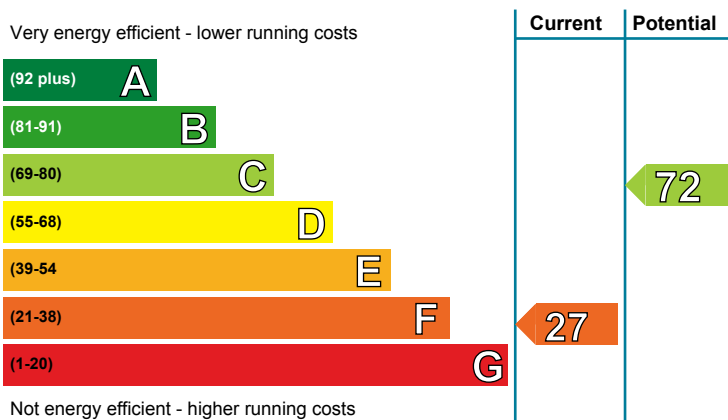
## Energy Efficiency Rating

This graph shows the current efficiency of your home, taking into account both energy efficiency and fuel costs. The higher this rating, the lower your fuel bills are likely to be.

Your current rating is **band F (27)**. The average rating for EPCs in Scotland is **band D (61)**.

The potential rating shows the effect of undertaking all of the improvement measures listed within your recommendations report.
